THERMACAM®
INFRARED CAMERA

MAXIMIZE YOUR ASPHALT INVESTMENT

Infrared Scanning Revolutionizes Asphalt Paving

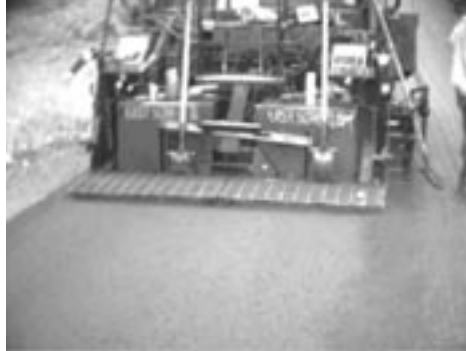
The thermograph reveals a temperature differential of about 50 Fahrenheit degrees in this mat directly behind the paver. The cooler areas could be a concern for poor adhesion, but are still hot enough to be successfully rolled. However, this differential would be out-of-spec for state highways in some states, including Washington and Georgia.

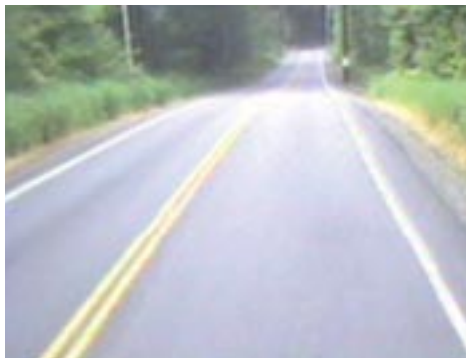
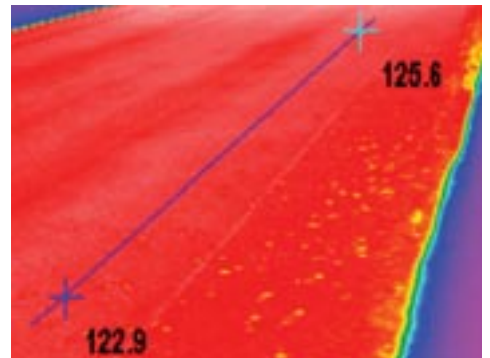
With only a 3 Fahrenheit degree differential, the longitudinal section shown in the thermograph indicates that this cooling asphalt mat exhibits exceptional thermal uniformity. The mean density of this asphalt mat is 2,205 kilograms per cubic meter, with a maximum of 2,247 kg/m³ and a minimum of 2,179 kg/m³. The visual photo of the road taken a year later shows no evidence of wear or degradation.

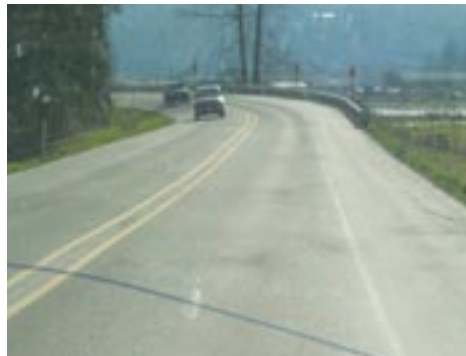
Asphalt that is cooler than about 170°F is relatively stiff, resists rolling, cures to a lower density than hotter areas and is prone to premature failure. Note the low-temperature spots in the thermograph, which are as cool as 70.9°C (159.6°F) and correlate exactly with the visibly worn spots in the visual photo of the same section of roadway.

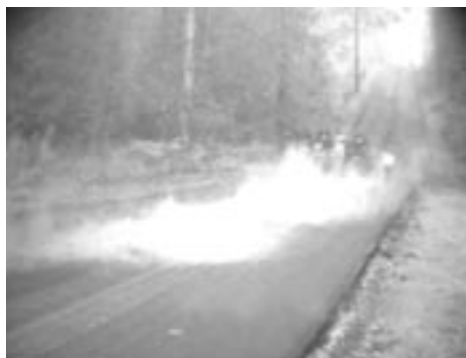
The thermograph shows the contrast in temperatures between the cool, curing lane to the right (113.3°F) and the hot mat being laid down on the left (222.1°F).
