Roof Surveys
START HERE!

IDENTIFY THE DAMAGE with ThermoCAM® RoofCAM

INFRARED SUCCESS STORIES

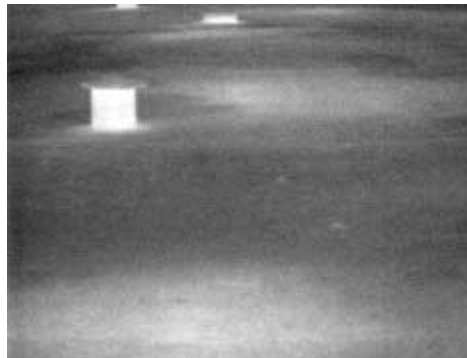
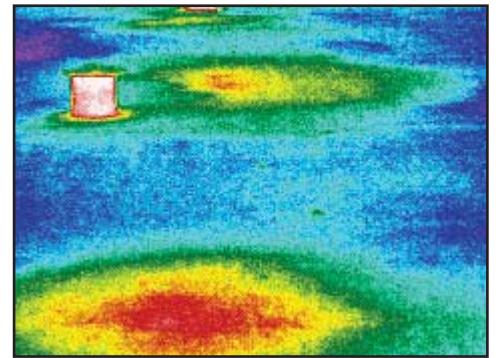
In this infrared image, the deteriorated areas of the roof are clearly shown at the time of inspection.

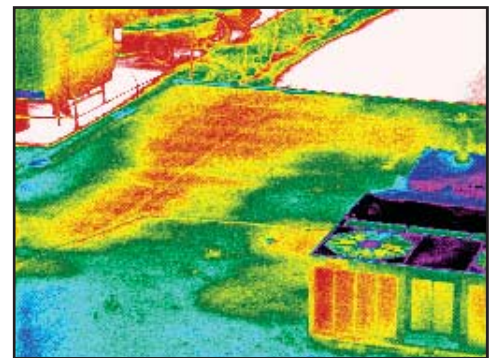
Interior infrared survey conducted during daytime hours reveals a central area of the deck that is saturated with moisture and in need of immediate repair, but is undetectable to the naked eye. Infrared can be used to scan thousands of square footage quickly and accurately.

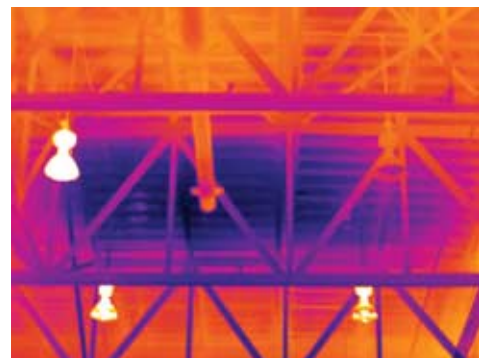
A pattern of air leakage is present in this photo. It was discovered that when snow would "drift" against this wall, a water leak would develop. Further examination of the base flashing detail revealed a significant crack at the bottom of the EIFS (exterior insulation finish system) through which melted snow was leaking into the building.

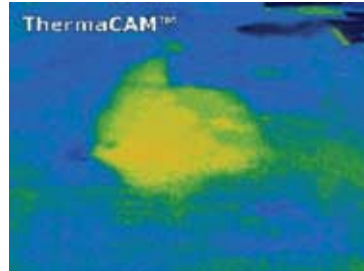
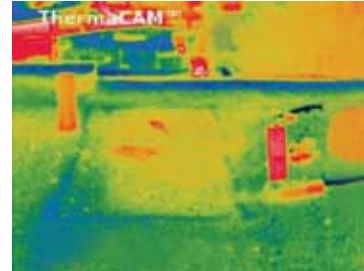
The IR images are of areas in a large roof, approx. 28,000 square feet. You can actually see the board patterns. The roof underlayment consisted of 2 inch thick perlite on a steel deck substrate. The waterproof top layer is built-up coal tar pitch plies with a pea gravel surface. The IR camera reveals wet perlite that can be torn out and replaced with dry insulation. Then a patch is installed to restore water tight integrity. This saves the customer from total roof replacement, which may cost in this case from \$90,000 to \$119,000 for a complete tear off and new roof. The total wet area found and removed was about 1,200 square feet. The cost for repair was just \$5,400.

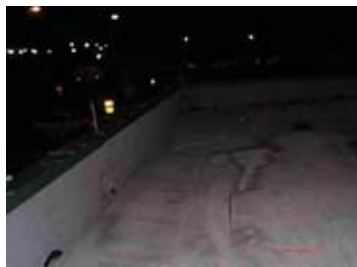
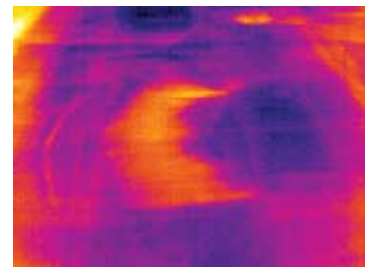
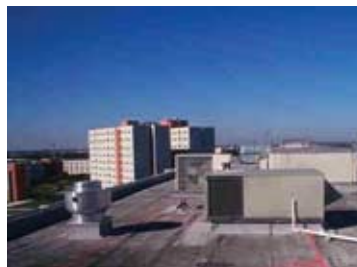
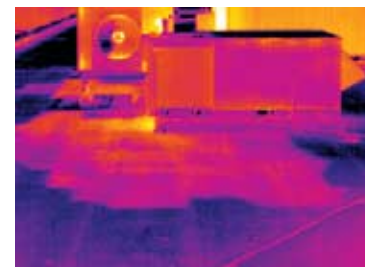
Sleuth Building Diagnostics, Inc. performed a post-construction infrared survey of the roof of the new Campus Support Complex at Florida Intl. University. The purpose of the study was to determine if water infiltration occurred during the construction of the roofing installation. The infrared survey revealed several areas of extensive water intrusion into the new roof system. These areas comprised approximately 4,000 sq. ft. of the new 70,000 sq. ft. roof, representing a potential cost of over \$30,000. None of this cost was incurred by the university, as the contractor replaced all areas of wet insulation and associated roof components at his own cost.
