Using IR to Diagnose Building Conditions

By Leonard A. Phillips, Senior Writer for Infrared Applications, FLIR Systems

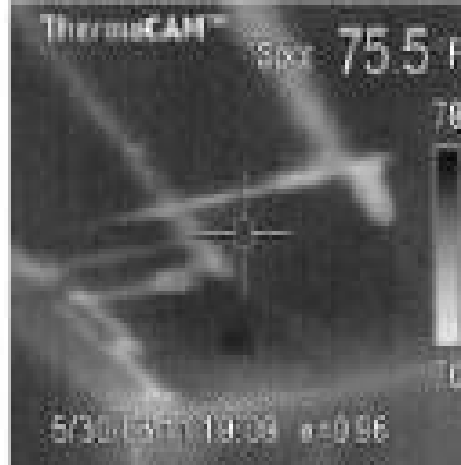
The thermogram (right) clearly shows a leaking bedroom ceiling (visible, left). The leak was assumed by the owner to originate in an upstairs marble-paneled bathroom in the \$3 million home. The estimated cost to rip out and replace the marble to access the plumbing was estimated at \$80,000! Further IR investigation absolved the bathroom and traced the source of the leak to a clogged weep hole under the threshold of a door leading to an upstairs porch.

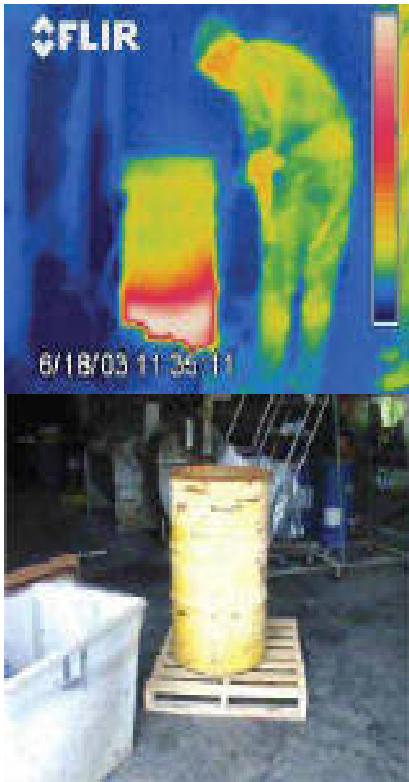
This thermogram dramatically reveals the general manager of a garment dying facility leaning toward a 32 gallon drum demonstrating a dramatic level of heat being generated by the exothermic reaction of sodium hydrosulfite and water. The property manager immediately summoned an industrial hygienist, who summoned the authorities.

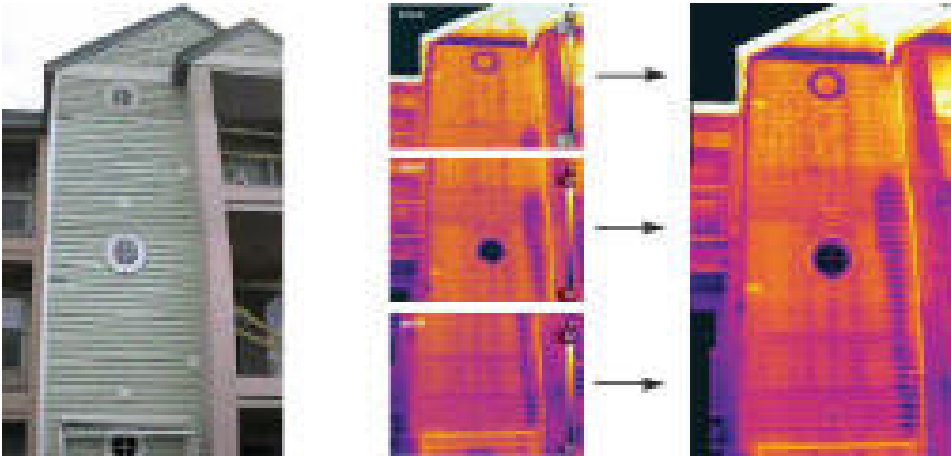
The thermogram of this vinyl-sided 3-floor apartment house clearly shows the path of a serious leak from a washing machine on the third floor, which is completely hidden within the wall. The thermographer used FLIR's Image Builder software to automatically "stitch" the three individual thermographs into one fully radiometric collage.

Software is key to generate reports quickly. Images in standard file formats such as .jpg and .gif can be inserted into Microsoft® Word. But dedicated software timesavers can shorten the report-generation process. Image mosaicing or stitching software uniquely knit multiple thermographic images together to create a single composite image that can facilitate diagnosis and repair.
