Use Thermography

for Picture-Perfect Roof Inspections

by Ronald D. Lucier and Leonard Phillips, FLIR Systems

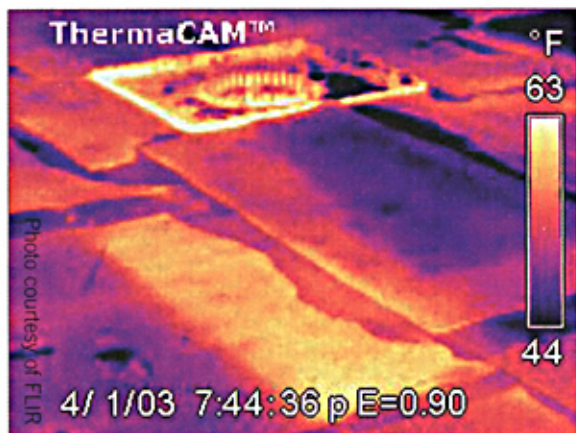
Figure 1. This thermogram was taken on April 1, 2003, at 7:44 p.m., about two hours after sunset. Leaks through seams and around the walkway and roof drain have allowed the underlying insulation to become soaked with water. The wet areas are relatively warm and clearly visible in this thermogram as red, yellow and white areas. Cooler, dry areas are purple and black. The color bar shows the measured temperature range of 44 F to 63 F.

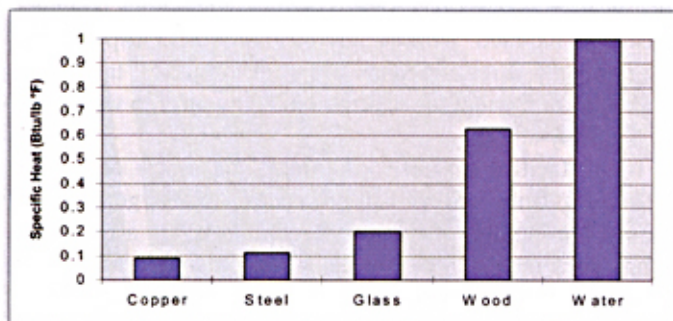
Specific heat of various substances. The greater its specific heat, the more energy is required to heat or cool a particular material. Water has a much higher specific heat than wood and subsequently cools down or heats up much more slowly than wood under similar conditions. This difference in temperature can be imaged and measured using an IR camera.

Thermography can pinpoint leaks in roofing and other building envelope inspections by exploiting the thermal properties of water. Water stores heat very well; it warms up or cools down more slowly than other materials common in buildings. This property is called "specific heat" by physicists.

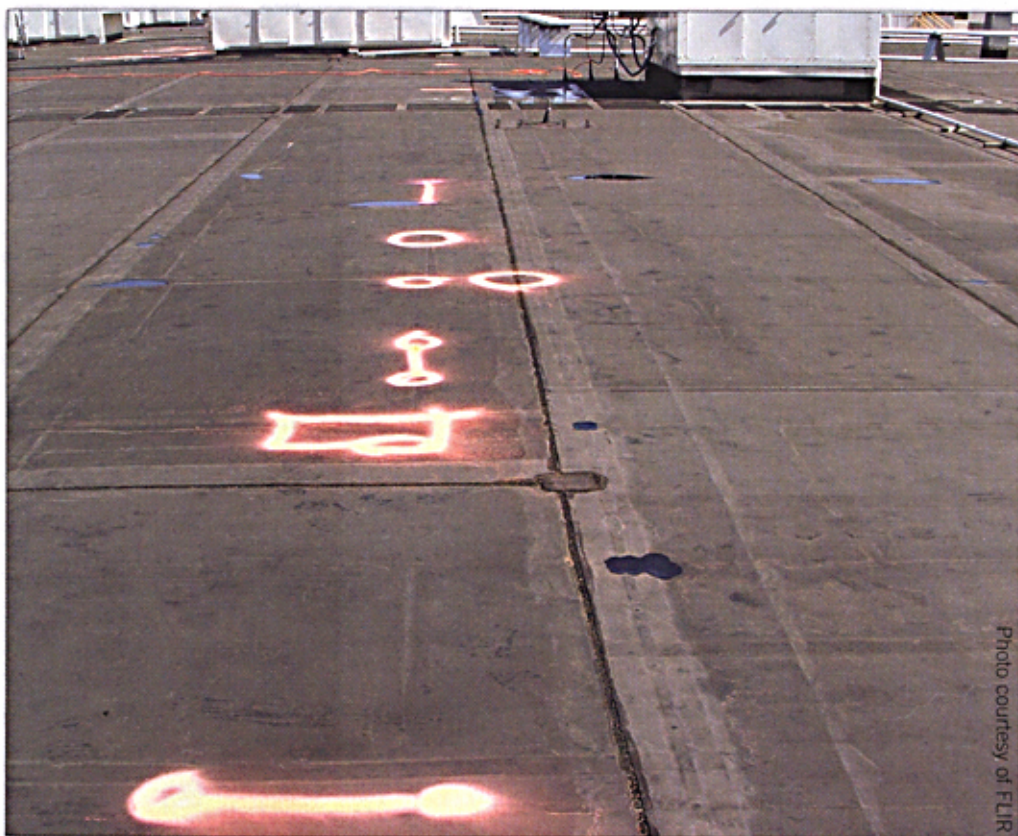
Figure 2. This photo shows a view of one typical section of a 600,000-square-foot EPDM roof on an electronics manufacturing plant. Areas of soaked insulation detected by thermographic inspection are spray-painted for identification. The building had experienced progressively severe leakage in "inopportune" areas. Prior to the inspection, the owner thought the entire roofing system would have to be torn off and replaced. However, it turned out that less than 3 percent of the roof area needed to be repaired, a savings of millions of dollars!

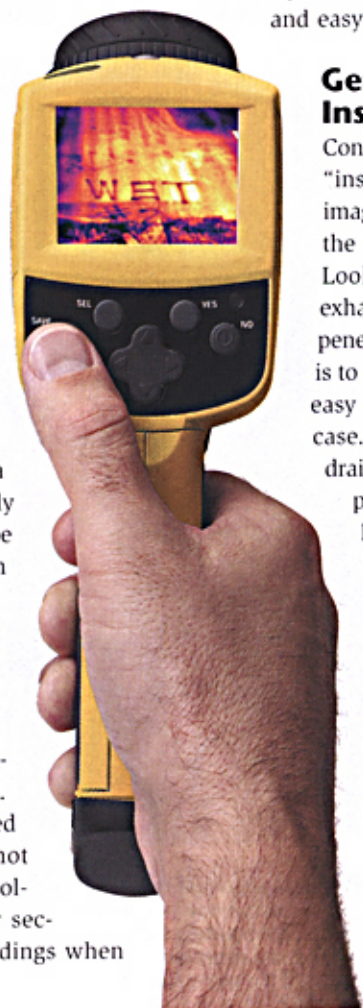
Figure 3. The FLIR ThermoCAM RoofCAM infrared camera provides crisp, real-time imaging, weighs less than 1½ pounds with rechargeable lithium-ion batteries, and can store up to 100 images onboard in standard JPEG format and download them to a PC for fast report generation. It is designed specifically for roofing and building envelope professionals. The size of a flashlight, it can be easily carried on ladders.

Worker safety is a primary concern for all roofing professionals and the tools used by these professionals need to increase safety, not increase any hazards. When shopping for an IR camera, it's important for the buyer to focus on "portability." The camera must be small, lightweight, rugged and easy to carry.

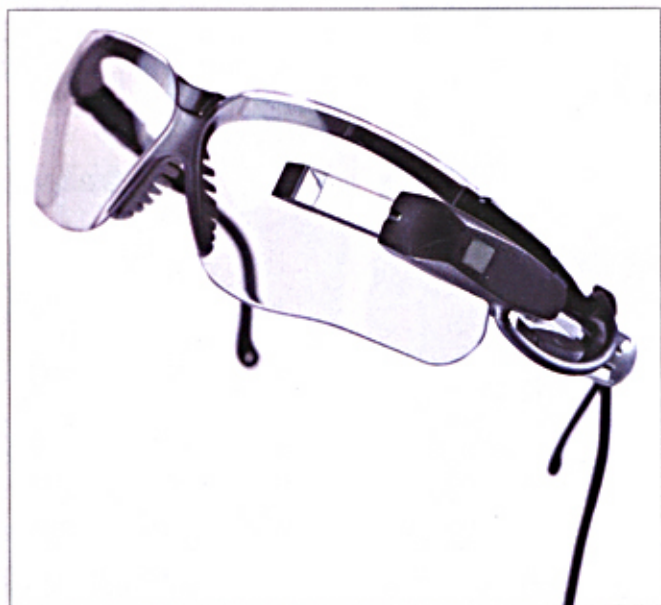
Figure 5. This heads-up display from FLIR systems enhances worker safety by enabling the thermographer to see the infrared image without having to look into an eyepiece or a LCD screen. The technology projects the infrared image onto a pair of safety glasses.
